SIO Shipyard Representative Bi-Weekly Progress Report		
Project: AGOR 28	Contract No.: N00014-12-C-0305	Shipyard: Dakota Creek Industries
Prepared by: Paul D. Bueren Scripps Institution of Oceanography (SIO) 297 Rosecrans St. San Diego, CA 98106	Date: 20 November 2015	Program Officer: Robert (Tim) Schnoor Office of Naval Research 875 Randolph St ONR 321 Arlington, VA 22203-1995
Distribution Statement A: Approved for public release; distribution unlimited.		Report No. A002.089

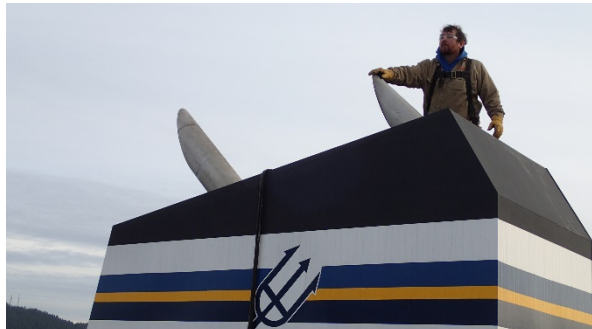
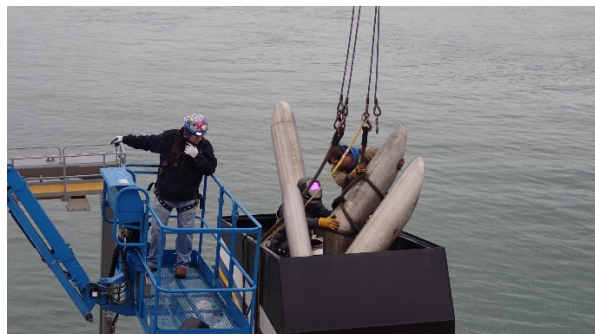
Exhaust Baffles

- **Main Deck Noise Levels** – This week NCE was on site testing the noise levels various exhaust pipe configurations. For each test all four engines were running and shore power was secured. The configurations were as follows:

- As-built
- Baffle in incinerator exhaust pipe only – (preliminary result- noise level decreased)
- Baffles added to all four engine exhaust pipes (preliminary result – no change from previous)
- Engine exhaust pipes removed so that exhaust was vertical and below the coaming of the stack. (preliminary result – noise levels increased)
- Engine exhaust pipes rotated near 90-degrees outboard vice the 45-degrees done on Armstrong. (preliminary result – no significant improvement when compared to Armstrong's current arrangement)

These are my observations. A full report will be provided by NCE. The take-away is that the expected result of a 6-db drop when the exhaust pipes were cut off below the stacks coaming was not achieved.
